# Florida International University Pedestrian Bridge Failure: A study in ethics

Rebecca A. Bowman, Esq., P.E., D.F.E.  
NSPE Sr. Dir., Ethics and Prof. Practice  
NAFE Executive Director

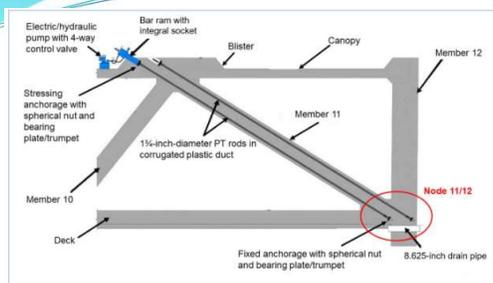
Figure 19. Main span, north end, showing post-tensioning specialized equipment in relation to location of PT rods in member 11. (Source: Structural Technologies, annotated by NTSB)

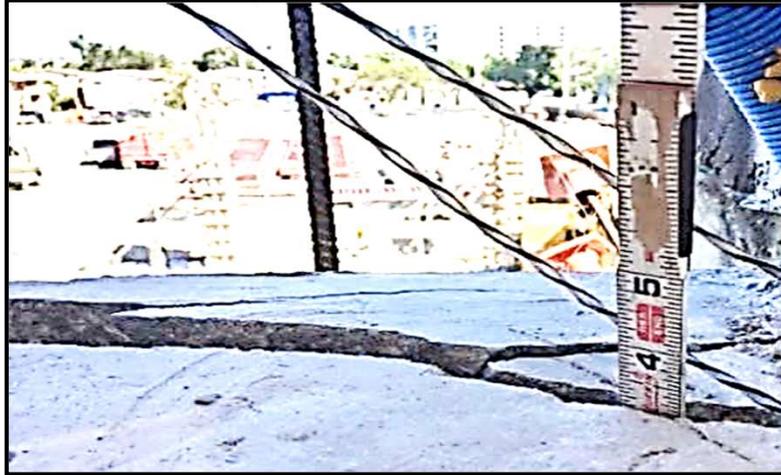
## March 13<sup>th</sup>: Cracks near 11/12 at north end 3 days **after** moving, 5 days before failure

Method	
March 13 9:45 a.m.	Email from FIGG to MCM	"We do not see this as a safety issue"
March 13 4:13 p.m.	VM from FIGG to FDOT	"But from a safety perspective, we don't see that there's any issue there, so we're not concerned about it from that perspective"
March 13 5:18 p.m.	Email from FIGG to MCM	"Again, we have evaluated this further and confirmed that this is not a safety issue"
March 14 10:50 a.m.	Email from MCM to Structural Technologies	"FIGG has further evaluated and confirmed that the cracks encountered on the diaphragm do not pose a safety issue and/or concern"

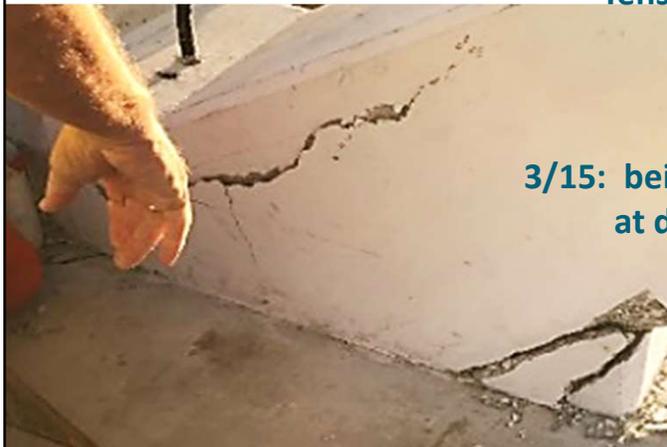
## Diagonal Member 11 (west view):

Tensioned for move,

de-tensioned,

**3/15: being re-tensioned  
at direction of FIGG**

*... based on the observations from MCM and CEI that the cracks got a little bit worse when they detensioned the PT rods, the direction from the design team was well, let's go back one step backwards, you know, from the design standpoint and go ahead and reinstall those PT rods on the north side only for truss member 11. Not truss member 2; only truss member 11.*

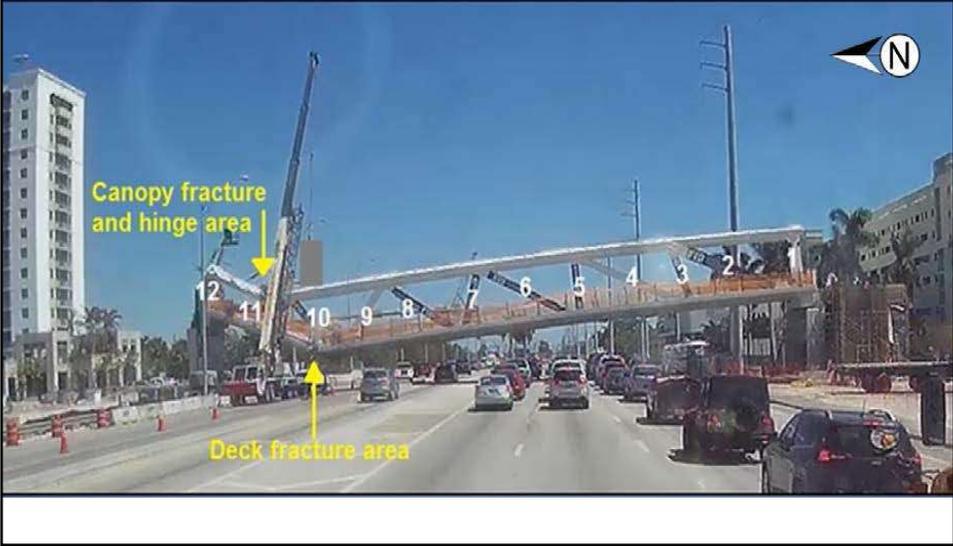
### Total Failure begins, 3/15, 1:46 p.m.

- Bottom line: the failure that started at the diagonal member 11 nodes was due to under-design of the connection.
- The FIGG Bridge Engineers construction plans inconsistently identified when intentionally roughened surfaces were needed to fulfill the assumptions of the bridge design.
- FIGG Bridge Engineers' analytical modeling for the bridge design resulted in a significant underestimation of demand at critical and highly loaded nodal regions.
- Entire design considered redundant, leading to lower safety factors . . . But when it wasn't

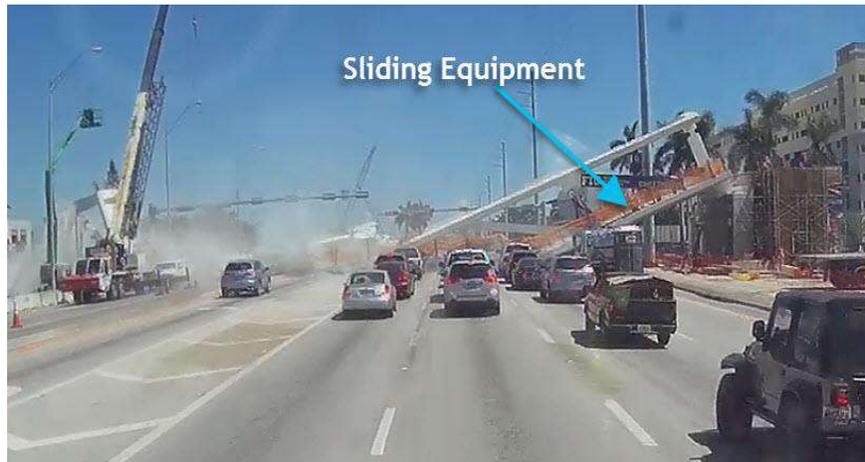
## Failure event complete

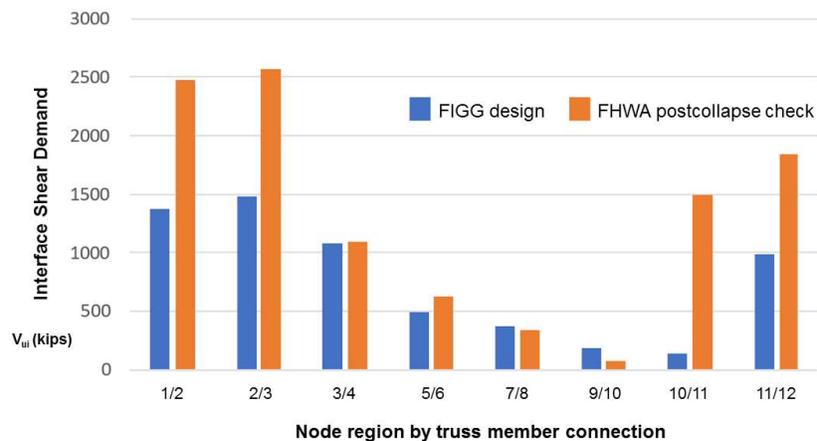
## NTSB vs. As-Designed Shear

- Remember the “cold” joints?
- Shearing force develops due to the angle between the diagonal member and the top/bottom member
- Shearing force resisted by two basic methods: rebar & friction on the interface
- Friction can be improved by “roughing” the concrete; not done here
- Worst case is no-load; usually use load factor of .9; FIGG used 1.25.
- NTSB: 13 additional square inches of rebar was needed at Node 11 to safely resist shearing
