Millington Bridge Pier Replacement

Brian K. Converse, P.E., S.E.
Satyam Mandloi, E.I.
2022

Summary

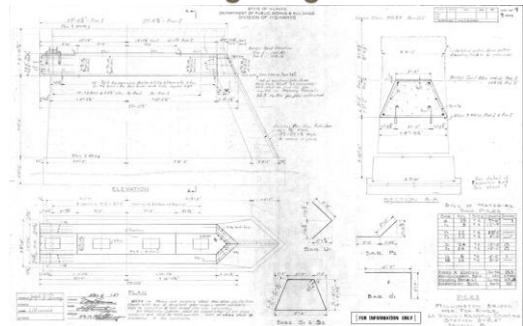
Piers (1958 Plans)

Note: We don't know exactly when the pier was built.

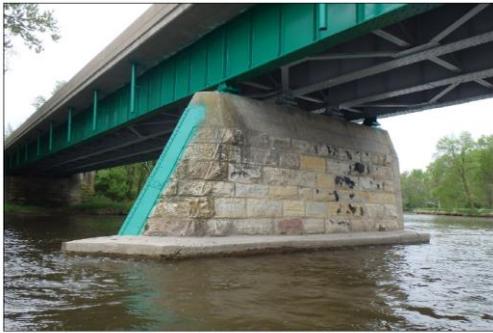
- Pier 1 (South Pier) was in poor condition at the time of inspection. Two areas of footing undermining were observed at the upstream nose and the southeast corner of the pier.

Photograph 4: Overall View of Pier 1 (South Pier), Looking Southwest.

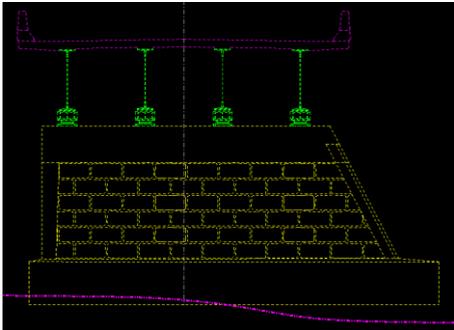
- Pier 2 (North Pier) was in critical condition at the time of inspection. Channel bottom scour and footing undermining was observed at the upstream half of the pier.

Scour at Pier 2 (North Pier)

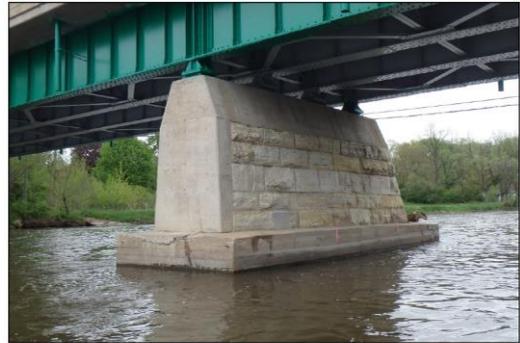
Photograph 5: Overall View of Pier 2 (North Pier), Looking Northeast.

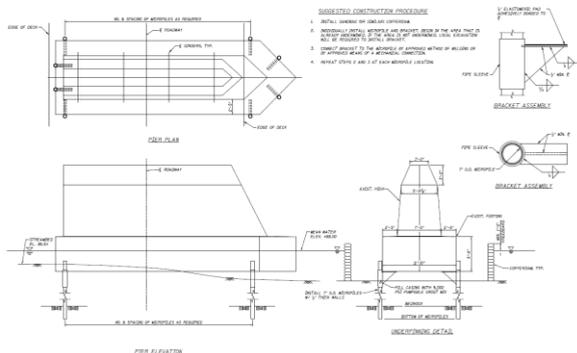
Alternative 1, Micropile and Bracket Underpinning

- Alternative 1 proposes the use of micropiles and a bracket assembly to underpin the existing footing.
- This alternative would require a shallow cofferdam to provide access for the installation of the underpinning brackets.
- This alternative directly transfers the load from the existing footing to the bracket to the micropile.
- The connection between the bracket and the micropile will be the weak point of the system. This creates an inefficient use of the micropiles increasing the amount of required micropiles.
- A potential drawback to this system is the geometry of the existing footing could create significant challenges to obtaining an effective transfer of force to the bracket.

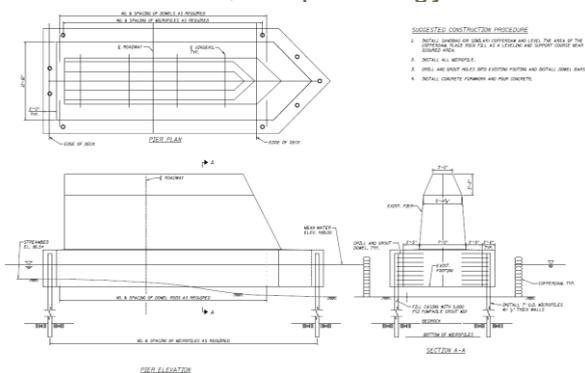
Alternative 2, Micropile Footing Jacket

- To mitigate the concerns about engaging the footing via a bracket, Alternative 2 utilizes micropiles driven around the outside of the existing footing.
- After the micropiles are installed, dowel bars will be installed into the existing footing and concrete will be placed to create a force transfer from the existing footing, through the bars and into the micropiles.
- This alternate has two significant drawbacks:
 - The condition of the existing footing may be too deteriorated to provide adequate bonding and load transfer to the new footing jacket.
 - The footing jacket would also increase the total width by 2'-0" on every side of the existing footing, and therefore, the hydraulic opening will decrease.

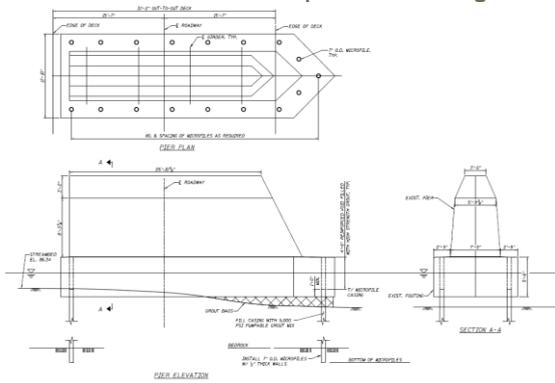
Alternative 3, Micropile Thru Footing

- With the understanding that hydraulic impacts need to be avoided, Alternative 3 involves drilling micropiles through the existing footing.
- This alternative transfers the load directly from the footing to the micropiles via the bond between the grout and the existing footing.
- While this solution maintains a simpler load path, it still relies on the existing footing to transfer load.
- This option is also difficult to construct as the micropile equipment would have to work on the uneven surface of the existing footing and the drilled hole would have to be constructed so as to not compromise the integrity of the footing.

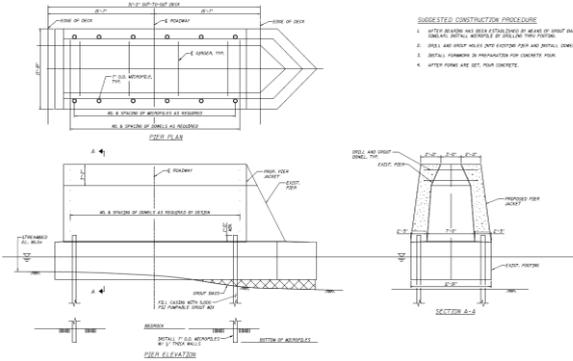
Alternative 4, Micropile with Pier Jacket

- Alternative 4 proposes to drill through the existing footing and install micropiles using similar methods as illustrated in Alternative 3.
- After the micropiles are installed, drill and grout holes into the existing pier cap and install dowel bars. To alleviate the moment failure from the unreinforced footing seen in Alternative 3, a pier jacket varying in width from 2'-3" at the base of the cap to 2'-11" at the top of the cap will be placed from the top of the footing to the top of the cap.
- The overall width of pier jacket will decrease from 11'-10" at the top of the footing to 8'-10" at the top of the cap.
 - Increasing the pier size will strengthen the pier, extending the design life of the bridge.
 - However, it will significantly increase the weight of the piers, requiring more micropiles, and decrease the hydraulic opening at the proposed column.

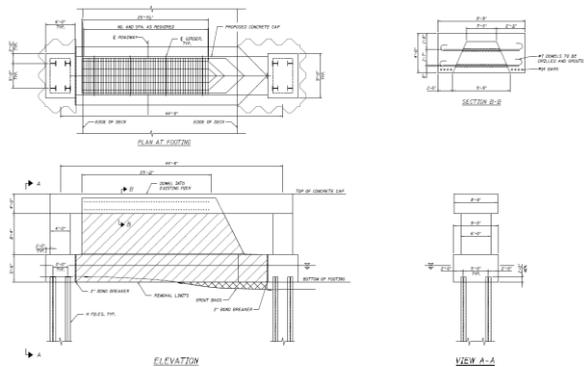
Alternative 5, Cast-In-Place Pier Cap Retrofit

- Alternative 5 constructs a "new" pier utilizing new footings and pier columns on the outer limits of the existing pier.
- The existing pier cap is retained and incorporated into construction of the new pier cap. The proposed pier footings can be supported by any deep foundation, H-piles, drilled shafts, or micropiles.
- The pier cap will be designed such that the entire load would be carried by the new cap and new reinforcement. Once the new cap is fully cured, the existing pier stem and footing may be removed.
- This solution would create an entirely new load path to a deep foundation and presents structural benefits.
- However, this solution would be difficult to construct and there would be temporary support requirements in order to replace the bearings and properly transfer load to the new cap.

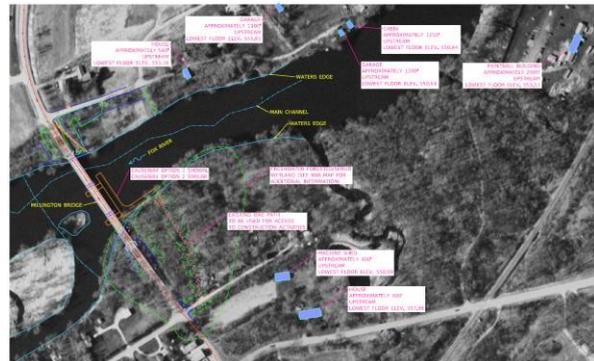
Hydraulic Impact

- Hydraulic modeling was performed to determine the effect the proposed causeways, spurs and cofferdams will have on the water surface elevations and subsequently on nearby properties/houses.
- The design criteria for the causeways was based on creating no impact on the base flood event and minimizing created head while still allowing access to construction equipment for a wide range of flows.
- The temporary causeways and cofferdam obstructions were designed to provide approximately one foot of freeboard for the structures above the five-year event.

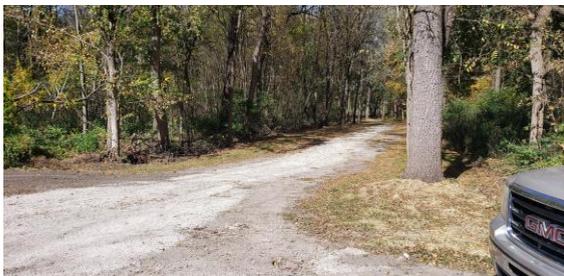
Bike path used to access the construction site.

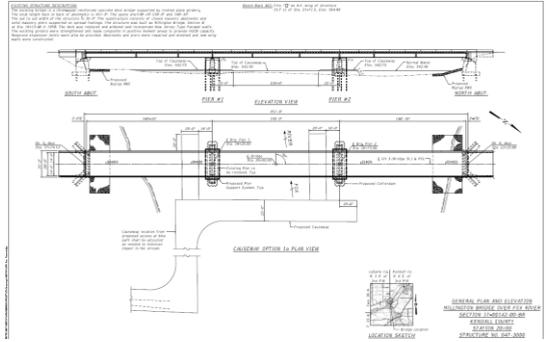
Causeway Option 1a

- Causeway was utilized in the installation of the cofferdams and temporary deck supports, demolition of the existing pier stems and construction of the new pile supported footings and pier stems.
- The project was permitted for two causeway options to give the Contractor a choice on which one would be the easiest and cheapest to construct.
 - Option #1a consists of using an old bike path on the Southeast side of the bridge to gain access to the river and construct a causeway to both piers.
 - Option #1b consists of using the bike path on the Southeast side of the bridge to build a causeway to the South Pier and using a clearing on the Northeast side of the bridge to build a causeway to the North Pier.

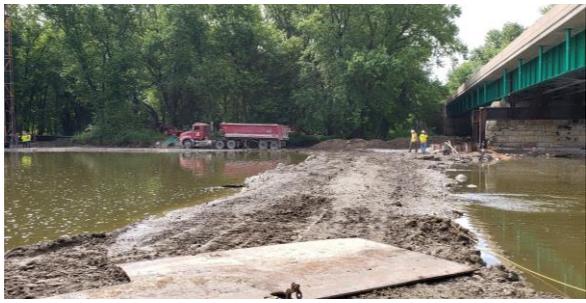
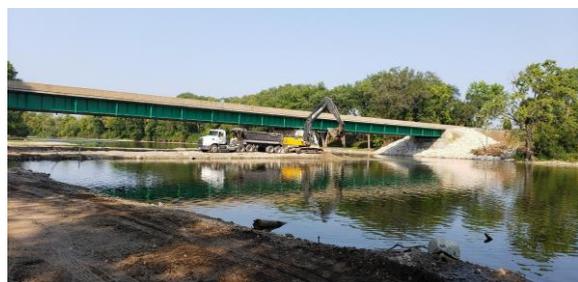
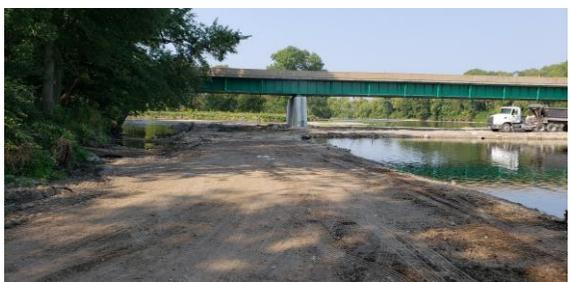
Construction of Causeway to the access the bridge

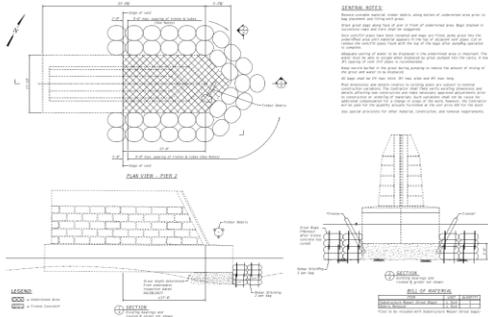
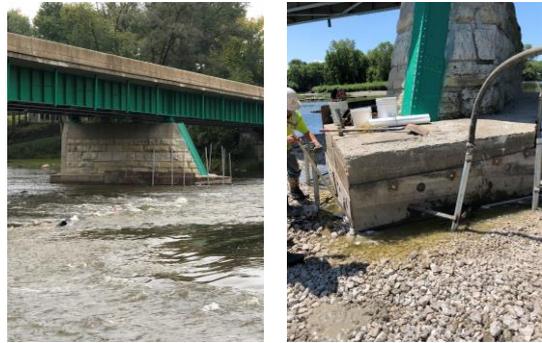
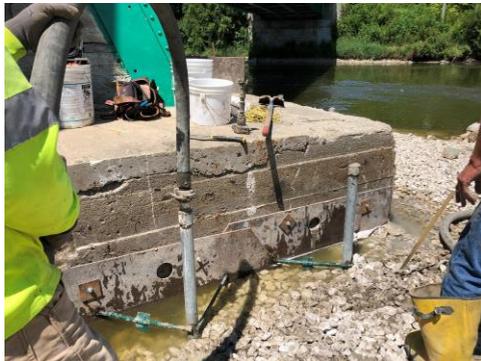
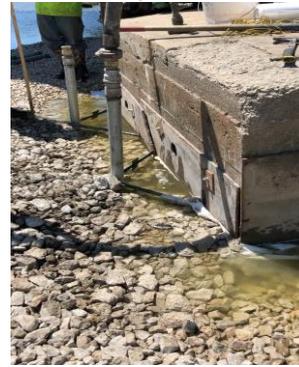
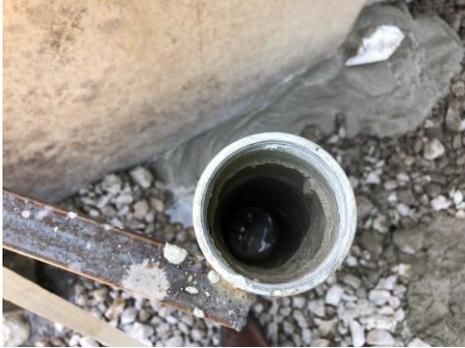
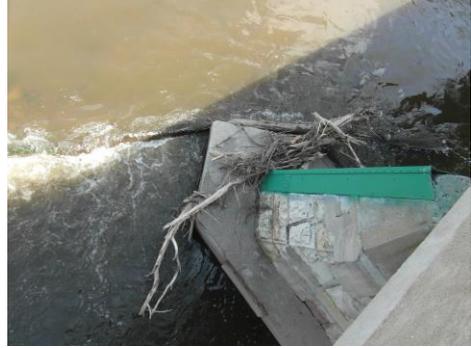
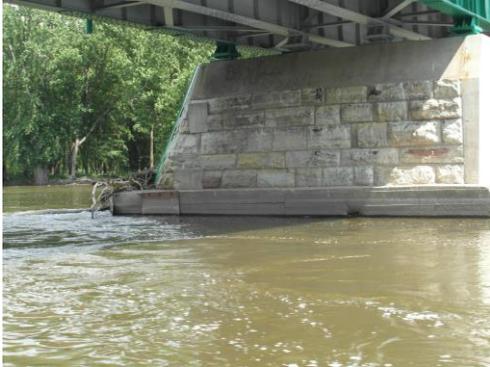
- Contractor jetted all the mud before performing grout repairs.
- Grout repair was also necessary to install piles and prevent shaking of the existing pier.
- There was a flood during the construction work. Since, the existing pier was stabilized using the grout bags around it, the bridge was still under operation, but the traffic was limited to only normal weight traffic, i.e., less than 5 tons.
- Contractor proposed an alternative method to stabilize the pier utilizing steel plates and we approved it.

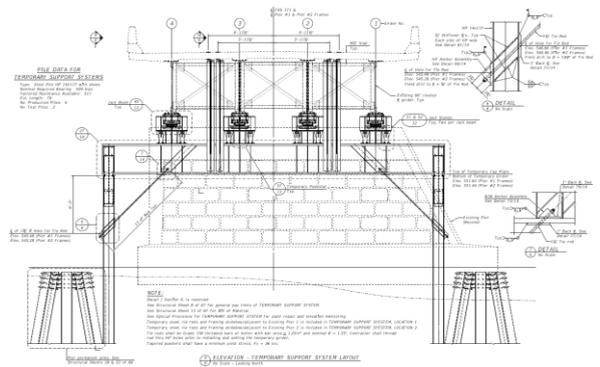
The transverse beam was W36x395.

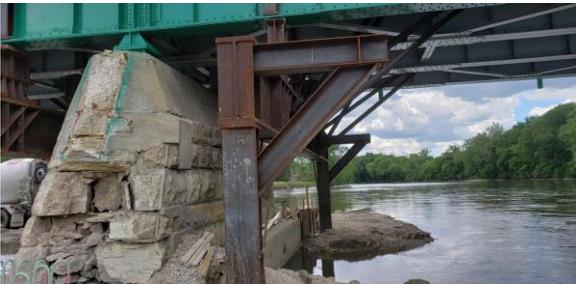
Use of kickers to provide stability for the beams in the temporary steel support system

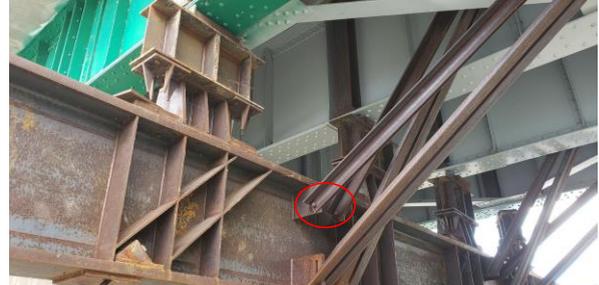
Holes for the brace were slotted.

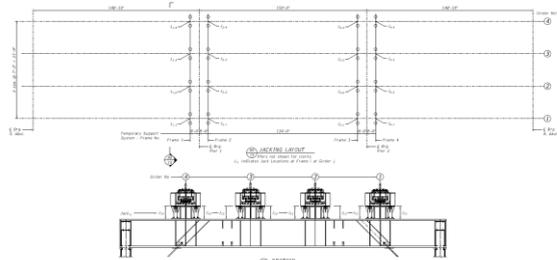
Use of hydraulic jack to lift the bridge deck and girder during construction work

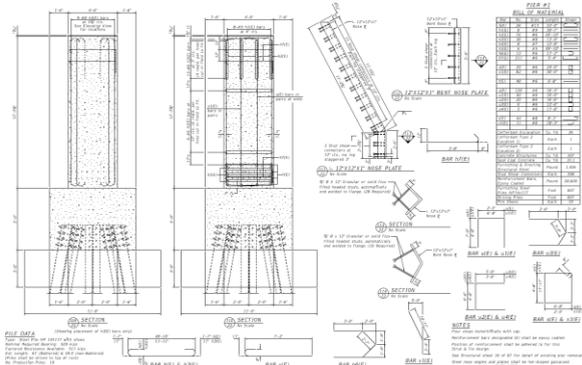
Proposed piles were HP 14X117 and 60' long driven to refusal.

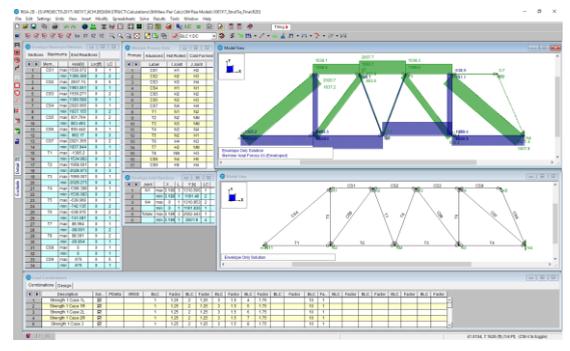
RISA Model

- Strut-tie model of piers resting on two battered pile support system.
- Strut-and-tie method was suitable in this case as it can efficiently transfer the load from the superstructure to the footing below.
- Strut-tie model for beam is a concept of designing the deep beams where the load path within the structural member is idealized in the form of truss system.

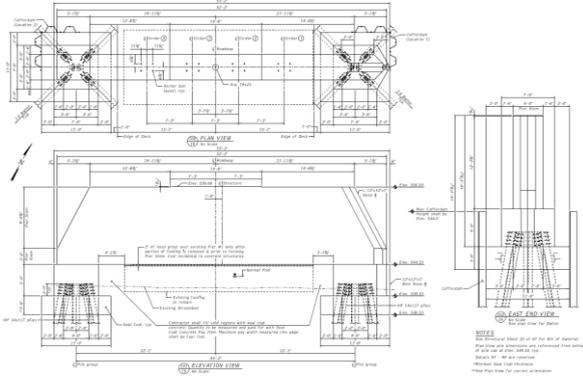
Existing footing was assumed to provide no bearing.

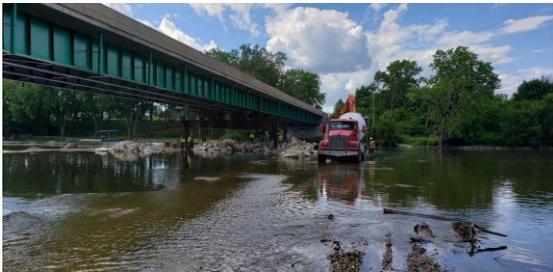
Removal of existing pier

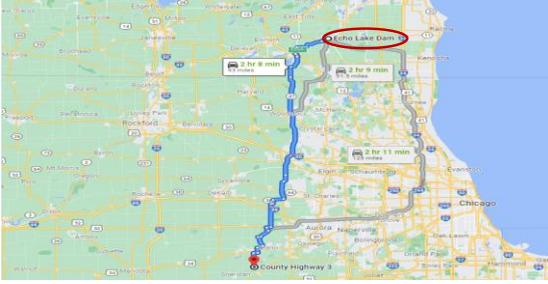
There is a dam upstream of the bridge and the Army Corps would release water during heavy rains. This would raise water level unexpectedly and flood the causeway.
